Periodic monitoring

## Diving report for Arnarlax.

Date 12.02.18 Time : 17:25

Location Hringsdalur

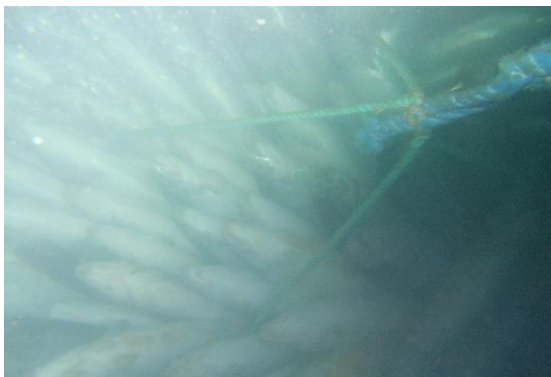
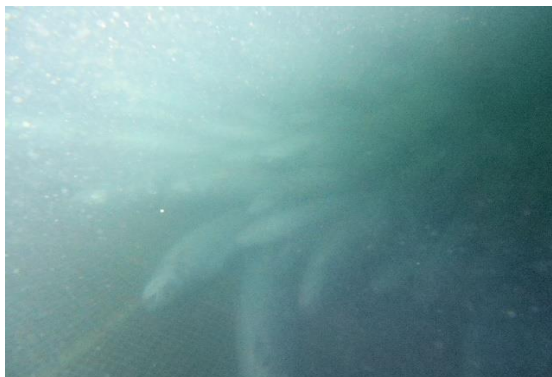
Dead fish in the basket.

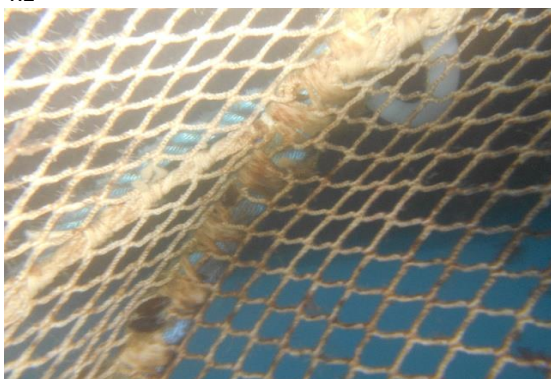
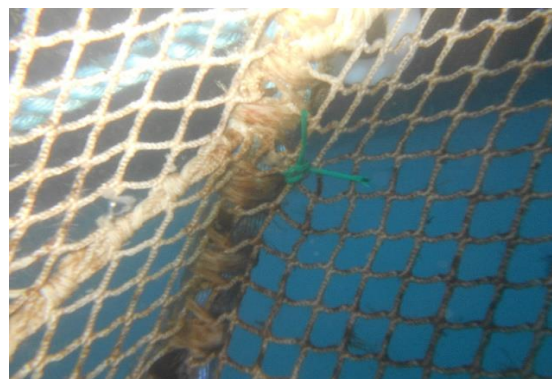
x1

All the holes were found around the surface area when the dive was performed.  
There was very much slack on the net and much movement in the water at the time when the pictures of the holes were taken.

Yes	No	Cause / repair
1 Was net good in sea		x	The net was very slack in the water because the bottom ring had been pulled up.
2 Was a hole on net/abnormal tearing?	x		Many holes were found and closed
3 Was dead fish collector in cage and working?	x		
4 Was dead fish in cage?	x		A pile of dead fish down by the basket
5 Was the net overgrown/where the most?		x	
6 Something else checked/worked at?	Net inspection, holes closed		
Other comments:	The net was very loose in the water because the bottom ring had been been pulled up to the surface, the net must have caught on to something and ripped, causing the holes.
